ROOF REPORT

Dr John Smith

4.0 INSPECTION DETAILS

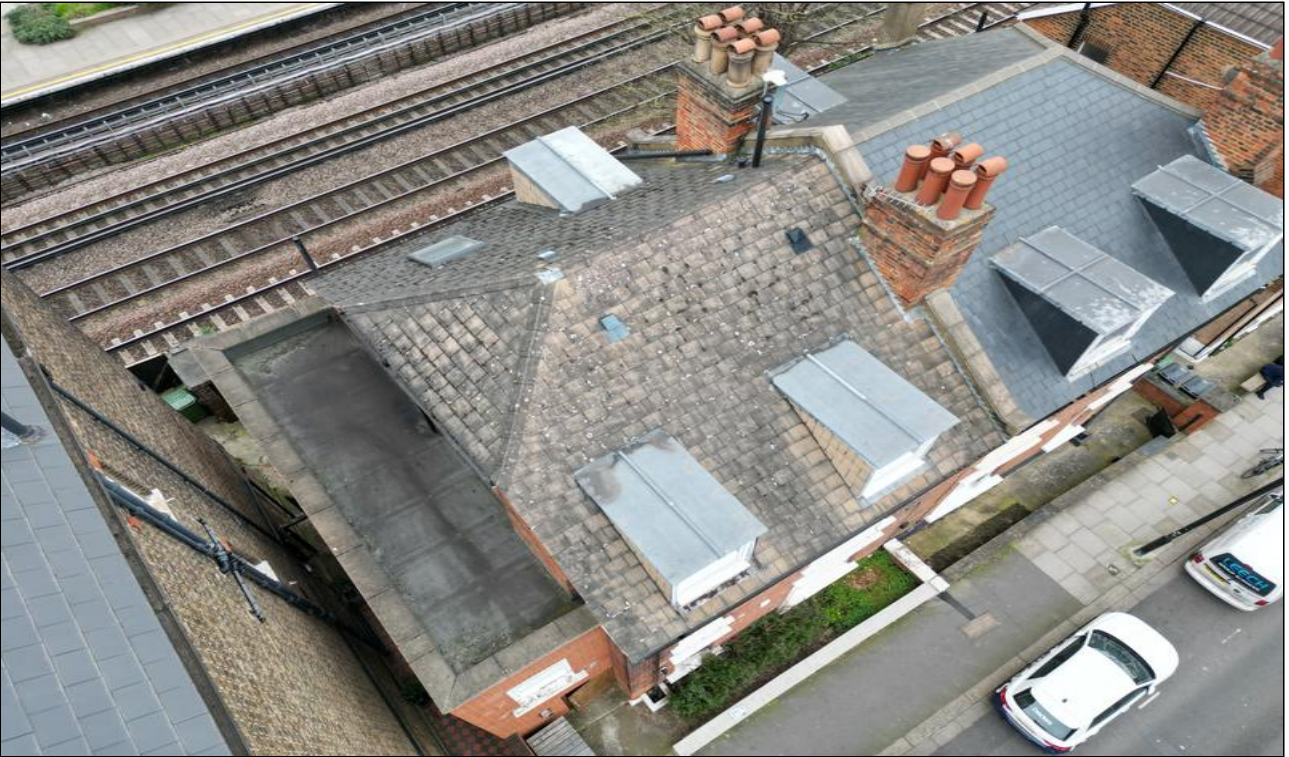
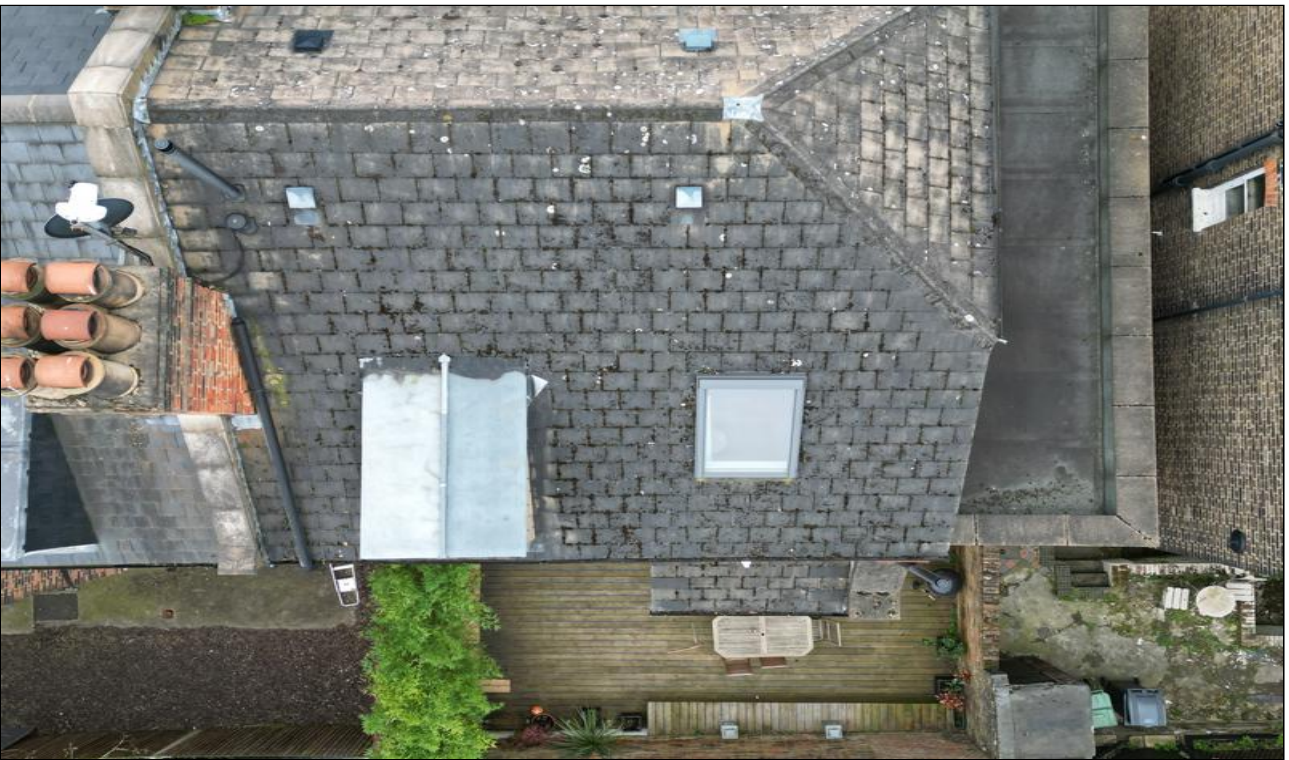
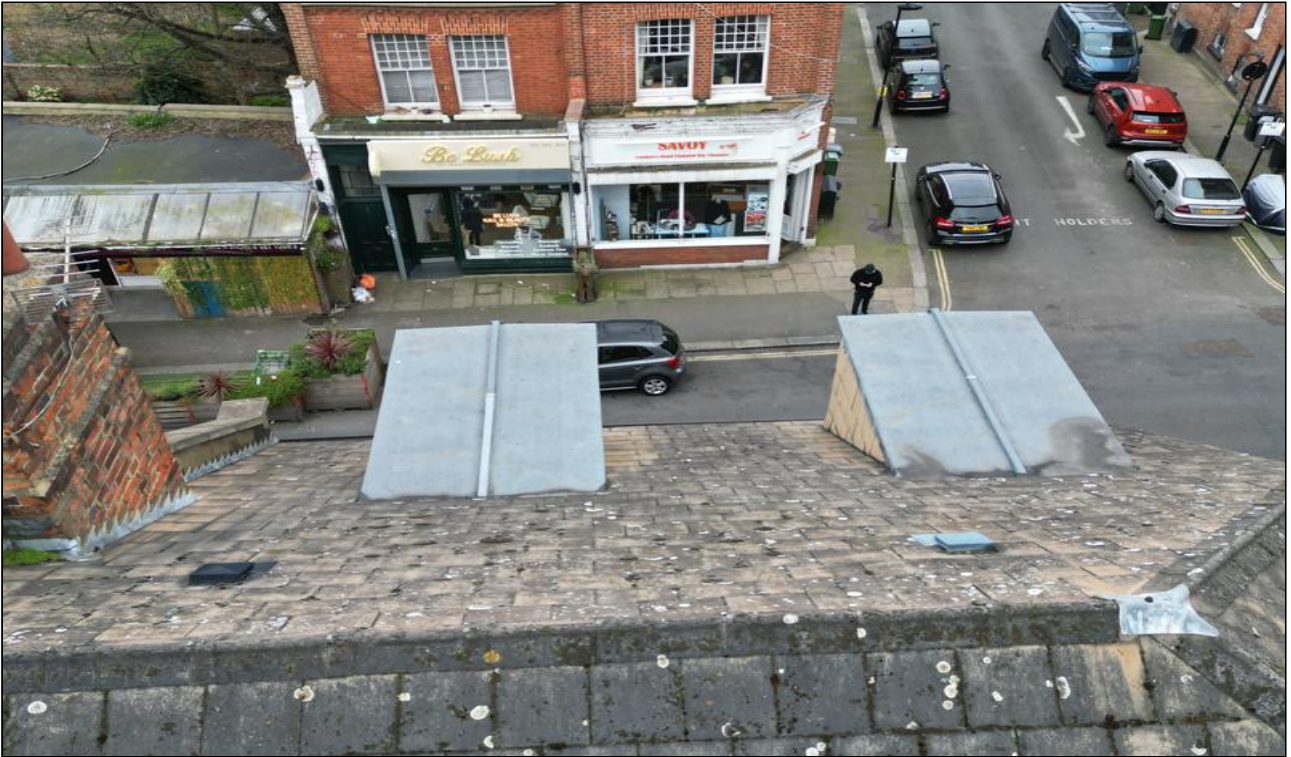
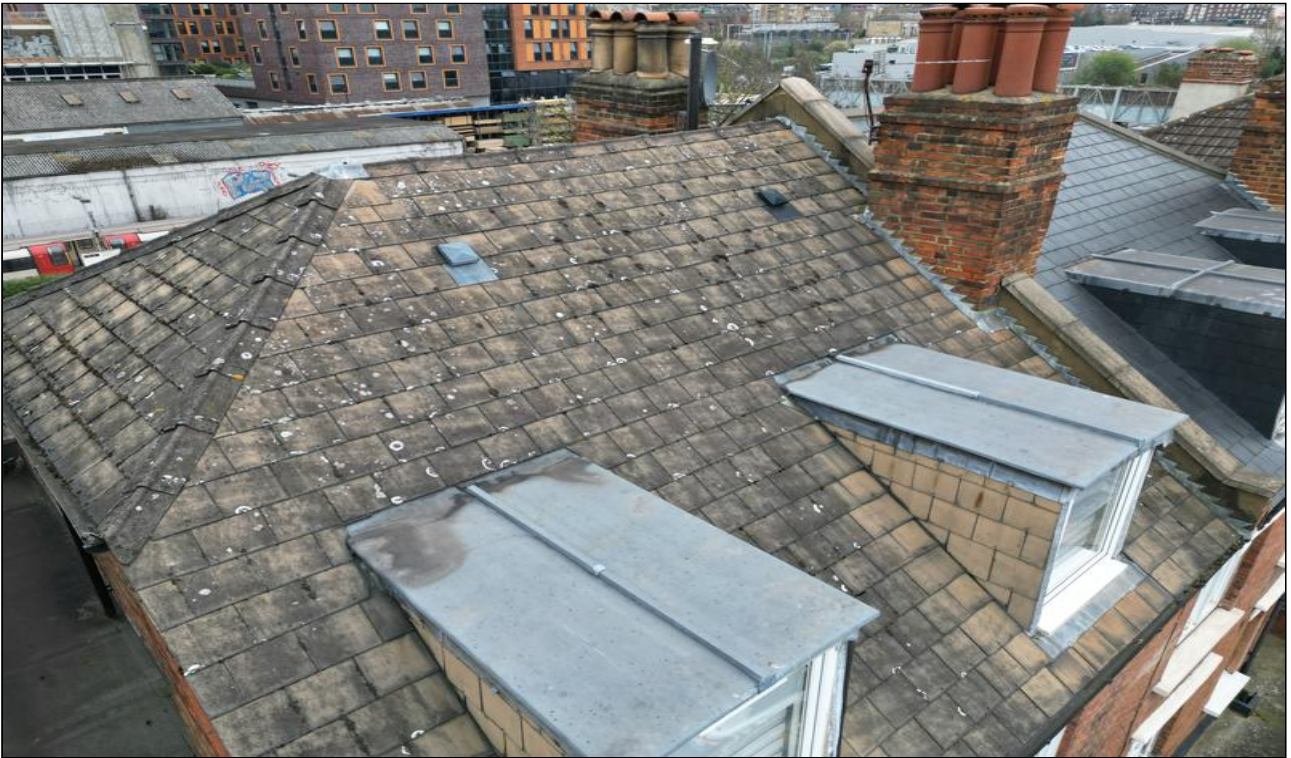
5.1 MAIN ROOF

CONDITION RATING: 2

The roof of the property is constructed with a pitched design and covered with Marley Eternit fibre cement tiles, which are nearing the end of their typical lifespan of up to 40 years. These tiles might contain asbestos, and it is advised to conduct an asbestos survey to confirm their composition. The presence of asbestos could significantly increase the cost of future roof replacements due to the requirements of the Control of Asbestos Regulations. It is important to use a licensed contractor for handling and disposal of any asbestos-containing materials.

Currently, the roof appears to be in satisfactory condition for its age, estimated at around 40 years, but annual inspections are recommended to monitor its condition. The roof covering's remaining life expectancy is projected to be up to 5 years, assuming ongoing maintenance and repair. Despite its present adequate condition, the roof is approaching the end of its serviceable life, and there is no guarantee regarding its longevity or continued waterproofing effectiveness. Regular maintenance and timely repairs are crucial to prevent potential leaks and associated damp issues.

Moss growth has been observed on the tiles, which could lead to damage and blockages affecting surface water drainage. It is recommended to remove any moss by a professional to prevent these issues. Given the age and condition of the roof, planning for its replacement within the next few years is advisable to avoid potential problems such as water ingress, mold development, and structural safety hazards. Delaying the replacement could also complicate obtaining insurance coverage, potentially leading to higher premiums or difficulty in securing a policy.

Routine annual inspections of the roof are essential to preserve its integrity and extend its lifespan. These checks allow for the early detection and remediation of minor issues such as cracks or weather damage, thereby preventing costly major repairs. They also help in fulfilling some insurance policy requirements, ensuring coverage continuity. Regular maintenance not only helps in extending the roof's life but also in safeguarding the property against unexpected repairs and financial losses.

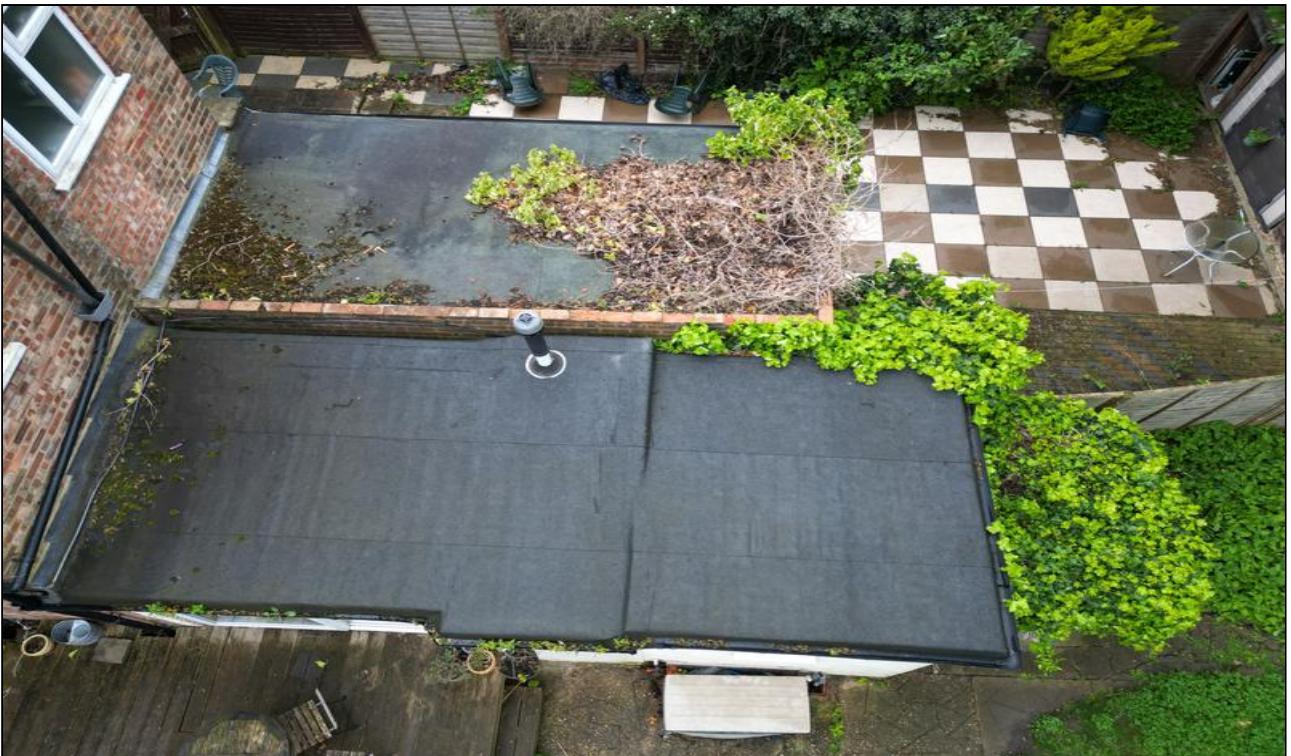
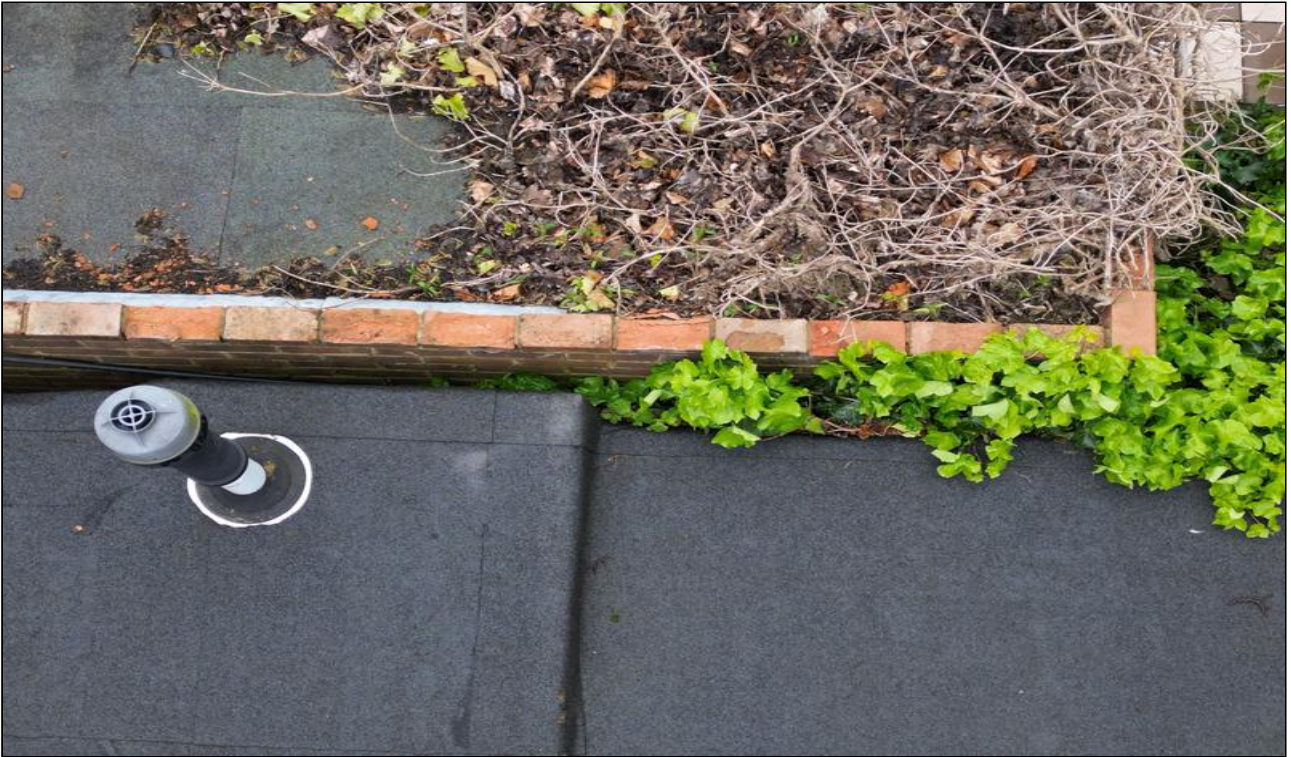
5.2 EXTENSION ROOFS

CONDITION RATING: 3

The rear extension of the property is equipped with a torch-on mineral felt roof covering, which typically offers a life expectancy of up to 25 years, dependent on the brand and adherence to manufacturer's installation guidelines. Despite appearing to be newly installed, the workmanship, particularly the installation of lead flashing over the roof abutments, is substandard. Although currently watertight, there is a risk of future leaks. It is advisable to consider replacing the lead flashing to enhance the roof's durability.

The roof covering is deemed to be in adequate condition with a remaining life expectancy of up to 5 years, assuming proper maintenance. However, due to poor installation quality, ongoing vigilance is necessary. Flat roof structures, such as this one, are prone to sudden failure, which underscores the importance of routine maintenance and monitoring. Potential buyers should be aware of the inherent risks associated with flat roofs, including the need for potential costly repairs.

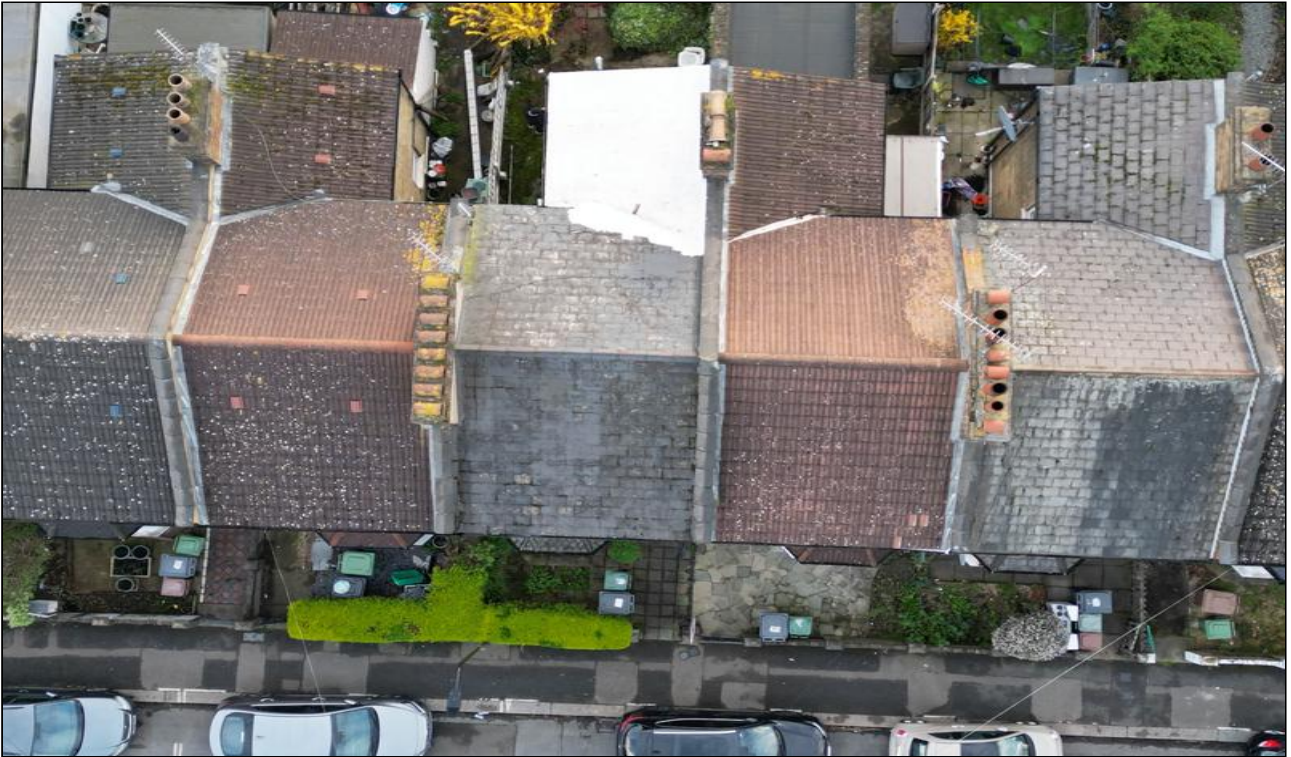
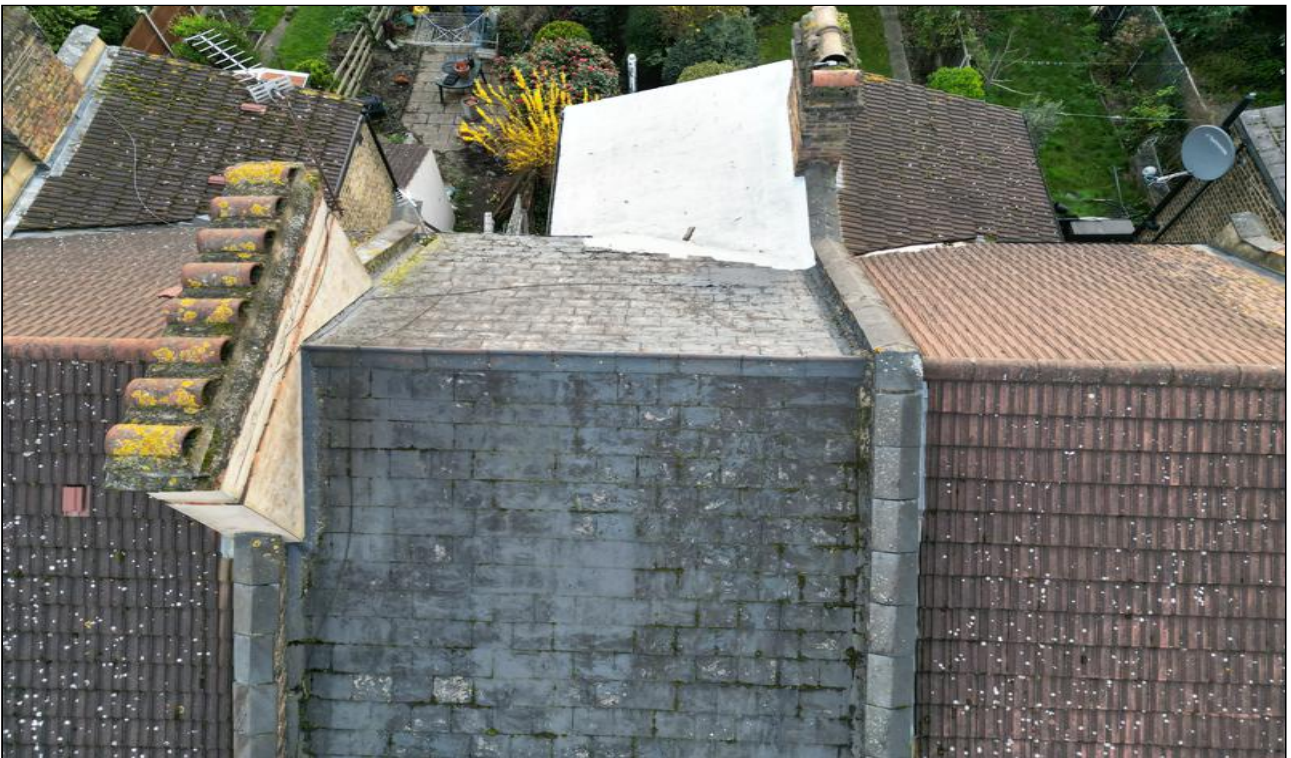
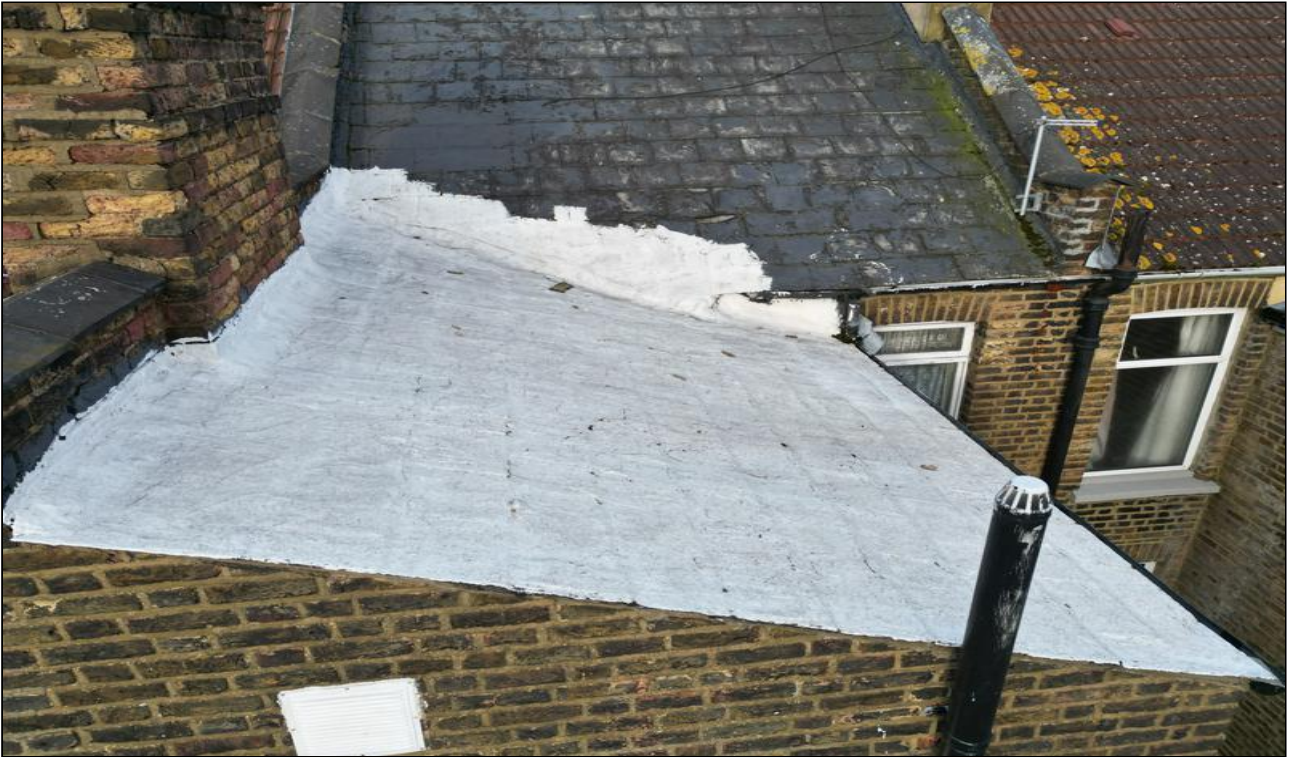
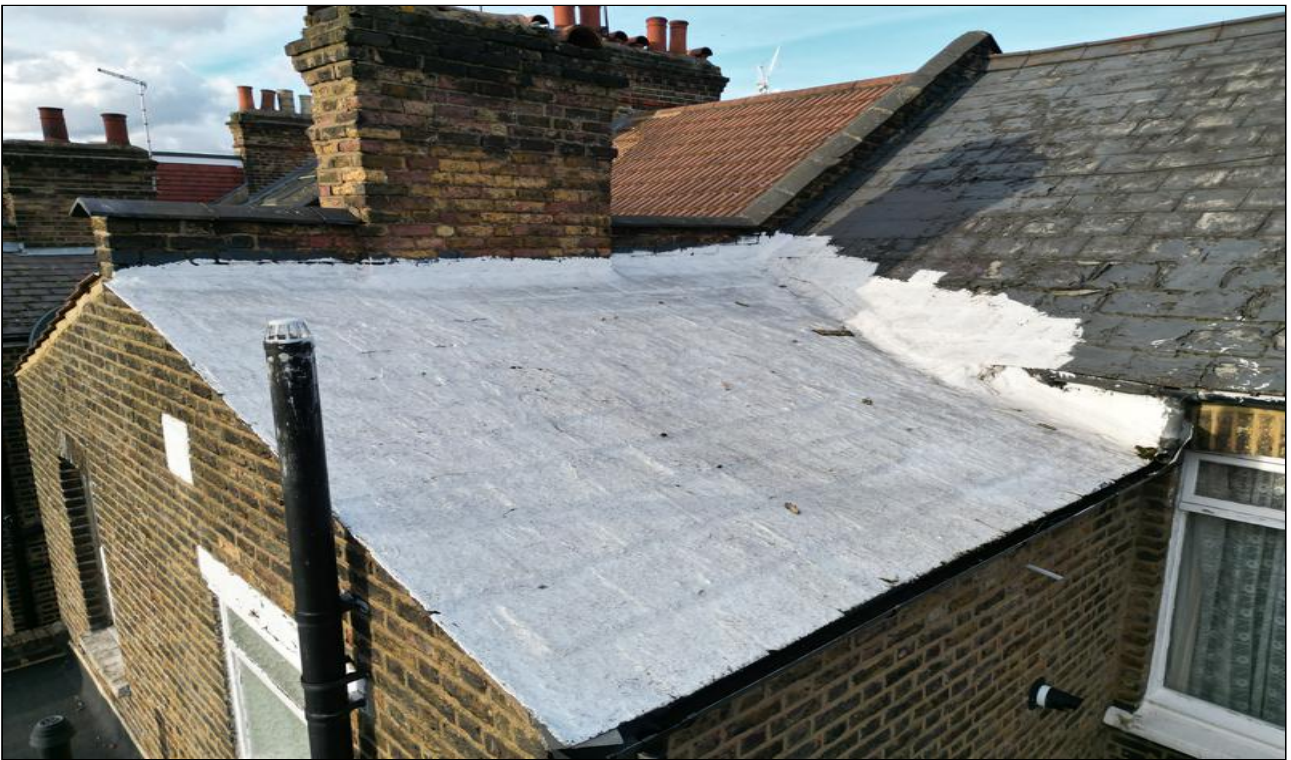
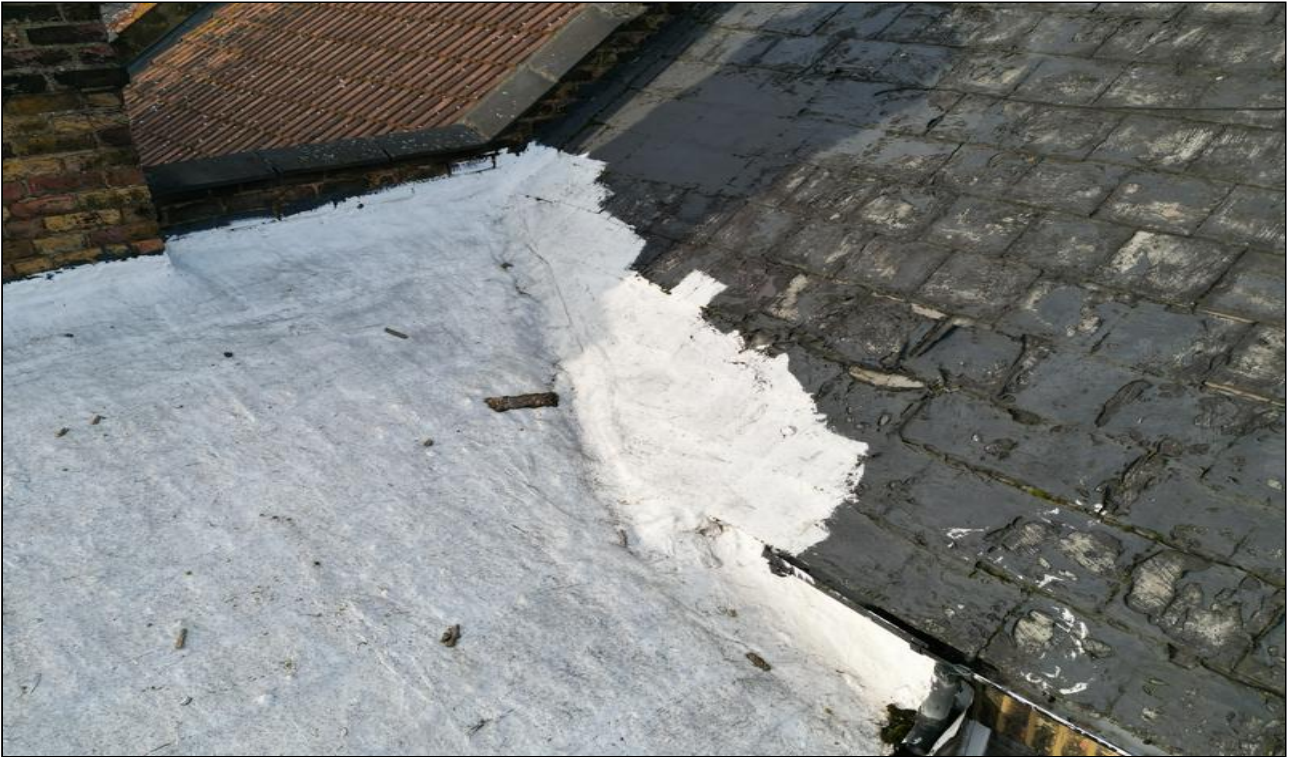
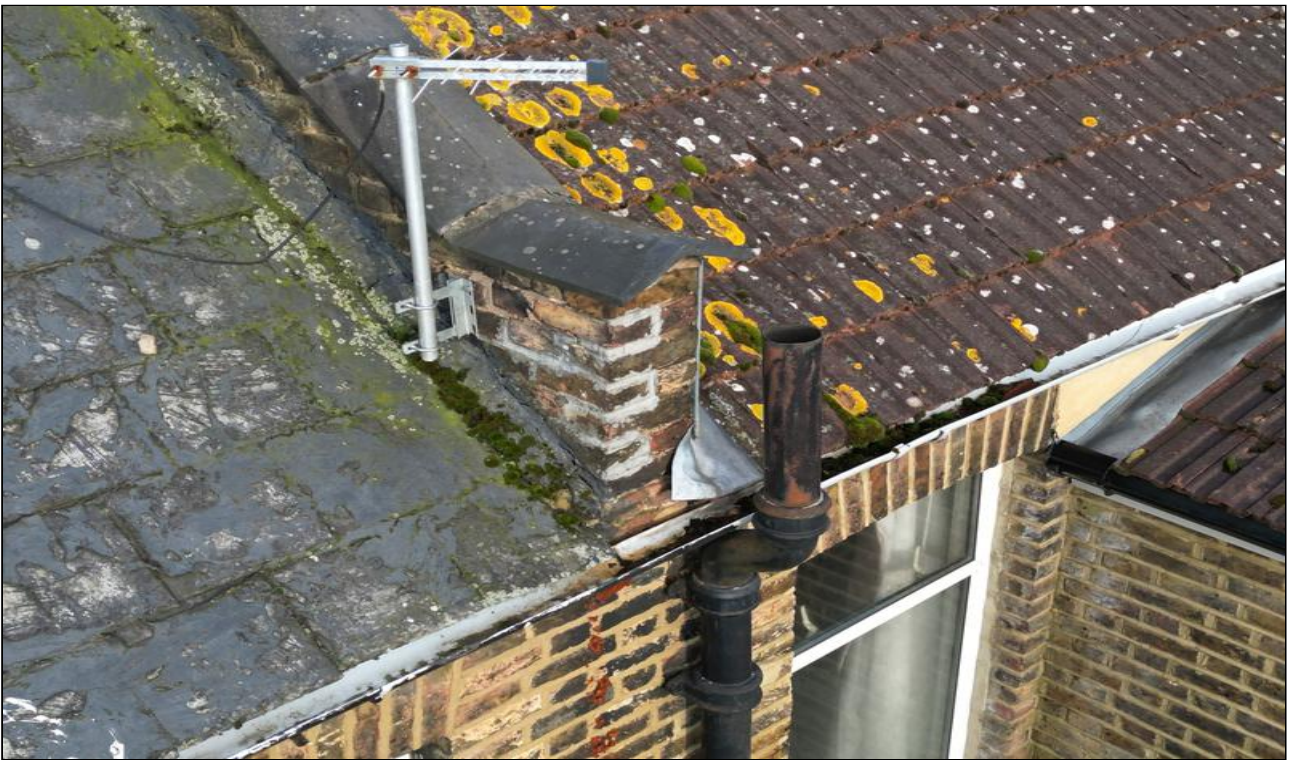
5.3 MAIN BUILDING

CONDITION RATING: 3

The roof of the property, featuring a pitched structure with natural slate tiles, appears to be original and now requires complete renewal. Natural slate typically has a life expectancy ranging from 70 to 100 years, depending on the slate's quality. However, the current condition of the roof covering indicates that it has reached the end of its useful life, with the tiles in poor condition and immediate replacement necessary to prevent potential problems.

The roof's flashing, currently sealed with cement—a less durable and cheaper alternative to more robust materials—also requires immediate attention. It is recommended to replace the existing cement flashing with code four lead flashing or an approved non-lead waterproof flashing material. Similarly, the pointing of the roof is unsatisfactory in parts and needs urgent repair.

Delaying these repairs poses several risks. Deteriorated tiles could become brittle and break, potentially leading to water ingress that causes significant damage and mold growth, which poses health risks. A degraded roof might also become a safety hazard, with loose tiles posing risks to people and property below, especially during adverse weather conditions. Furthermore, the presence of a severely damaged roof could affect the property's insurability, leading to higher premiums or difficulty in obtaining insurance.

It is crucial to replace the roof tiles and repair the flashing and pointing immediately to avoid these risks, ensure safety, and maintain insurance coverage. Failure to address these issues promptly could result in further damage and higher repair costs.

An annual inspection regime is vital to maintain the roof's condition and longevity. Regular checks allow for early detection and correction of minor issues like cracked or missing tiles and weather-related damage. This proactive maintenance helps extend the roof's lifespan, saves on future repair costs, and ensures compliance with insurance requirements. Regular inspections are not only a preventative measure but also a cost-effective approach to managing your property's upkeep.

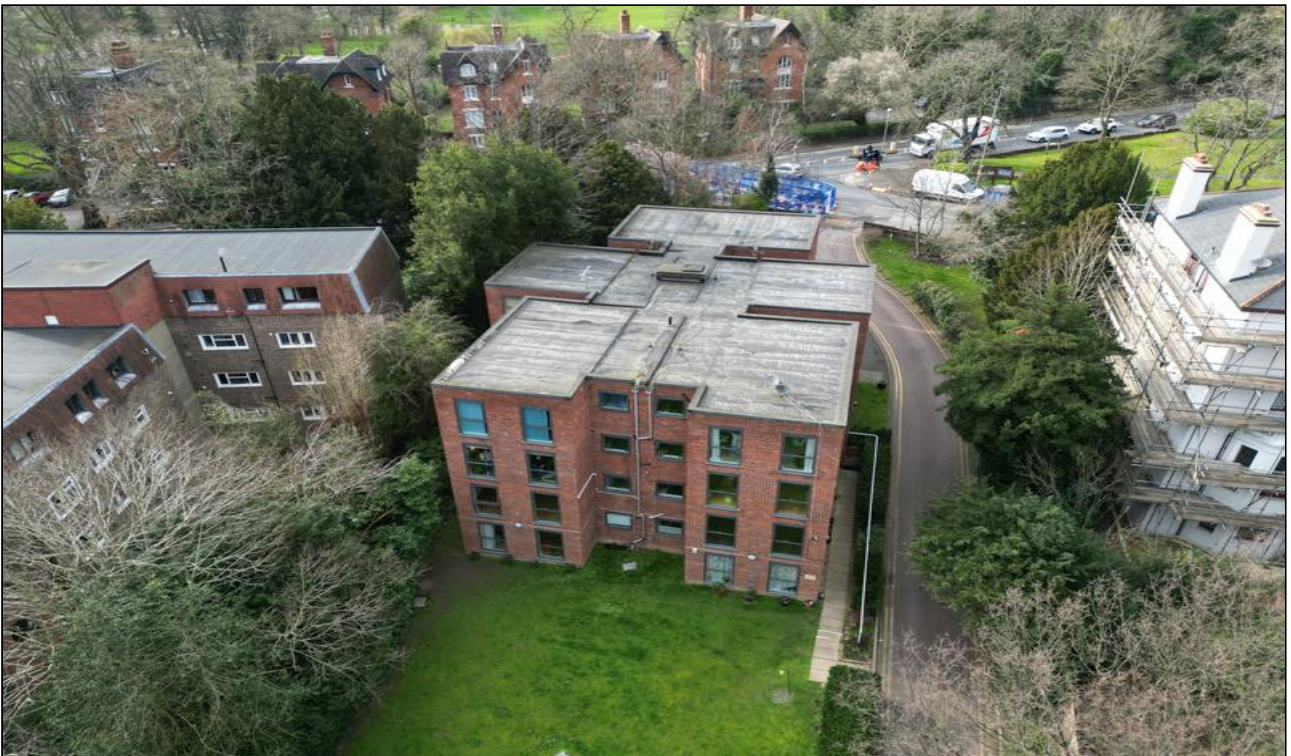
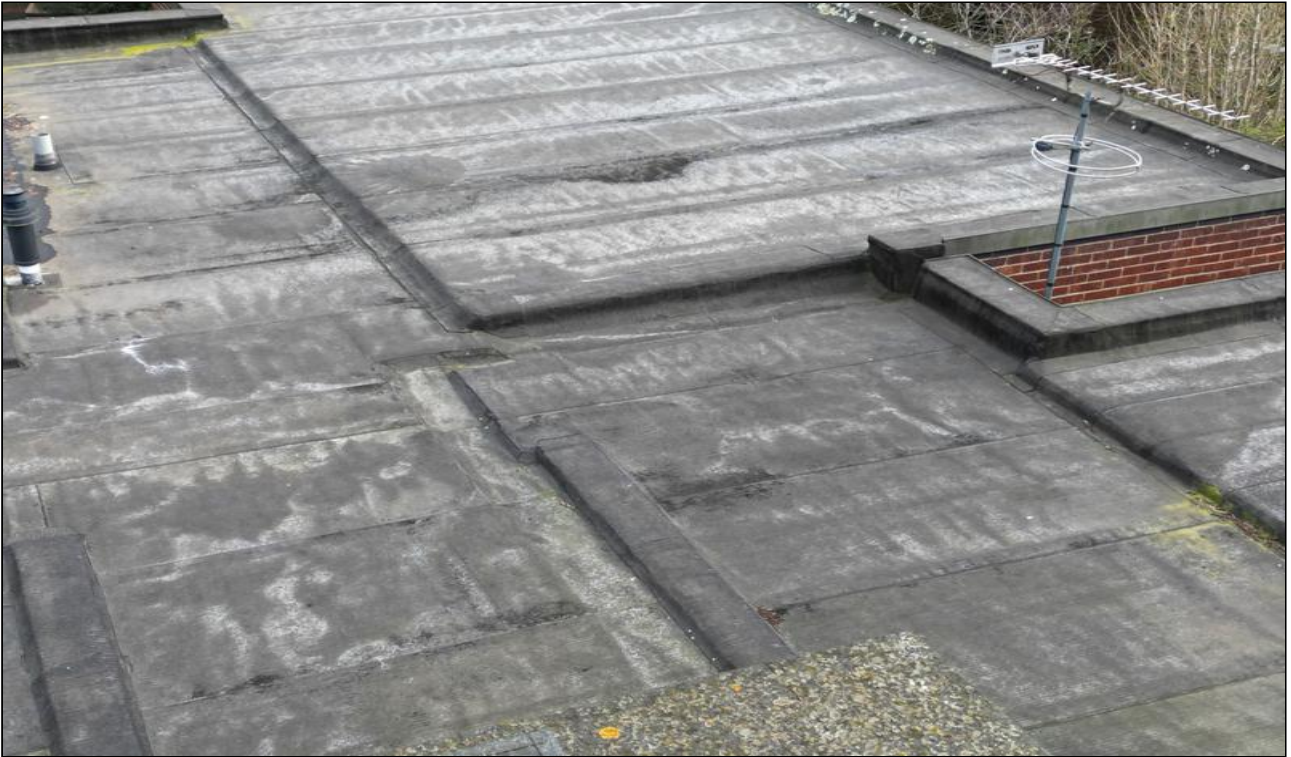
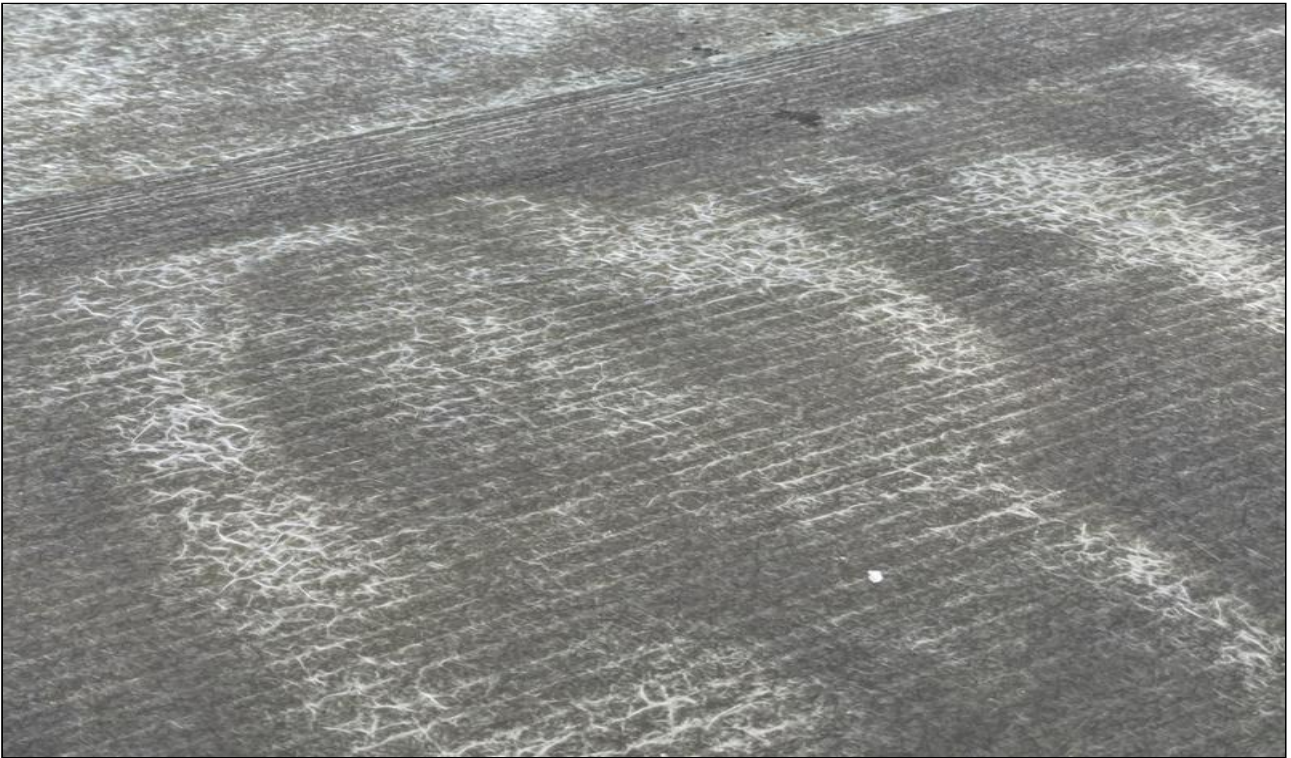
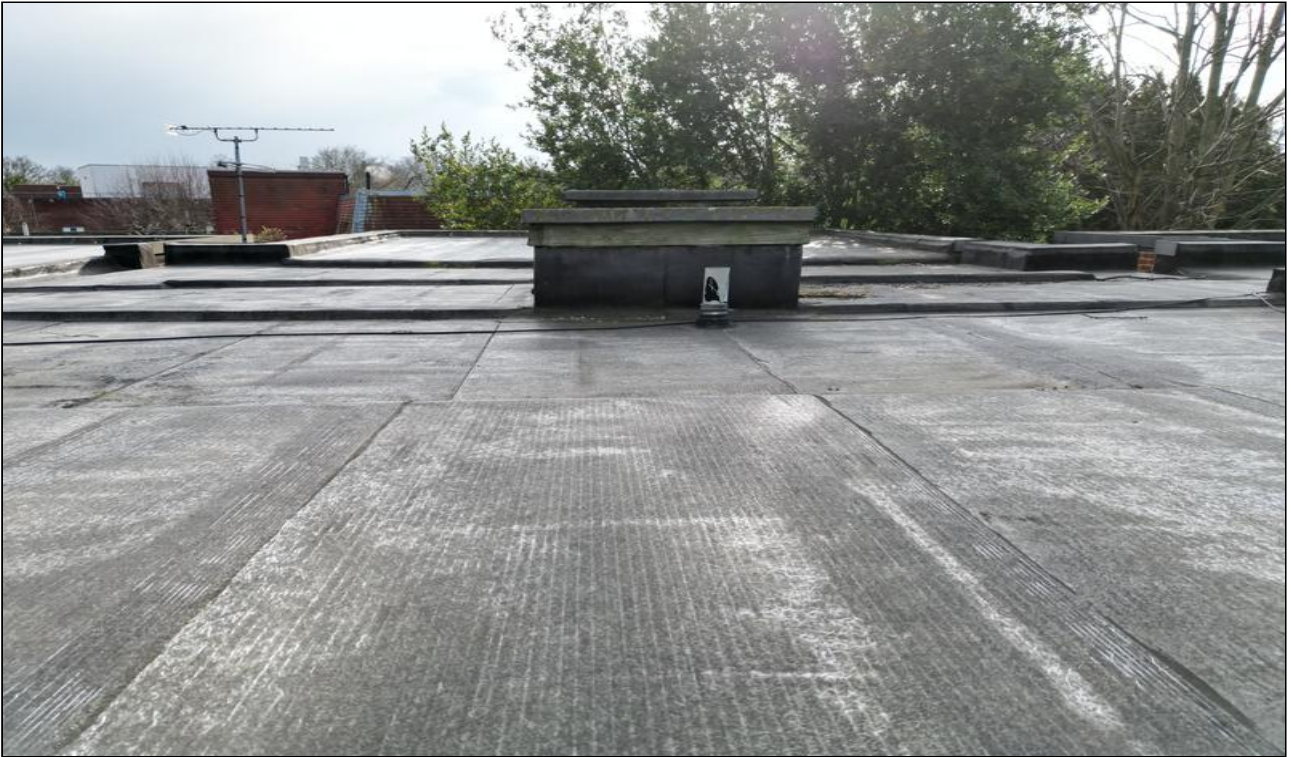
5.4 COMMERCIAL FLAT ROOF - BLOCK

CONDITION RATING: 3

The roof of the property features a flat design covered with mineral felt roofing, which typically offers a life expectancy of up to 25 years, dependent on the manufacturer's specifications and environmental conditions. Current assessments indicate that the roof covering is approximately 30 years old and has surpassed its expected lifespan, rendering it unsatisfactory and in need of immediate replacement.

Given the condition of the roofing material and its age, the estimated remaining life of the roof is assessed at 0 years, indicating that replacement should not be delayed. It is crucial to replace the roofing material now to prevent potential leaks and other related damage that could affect the integrity of the property.

To maintain the condition and extend the lifespan of the new roofing once installed, it is advised to perform annual checks on the roof components. These regular inspections are essential for identifying any early signs of wear or damage, allowing for timely interventions that could prevent more extensive and costly repairs in the future.
